April 29, 2020

Re: I-66/Route 123 Chain Bridge Road Construction Runoff Issues

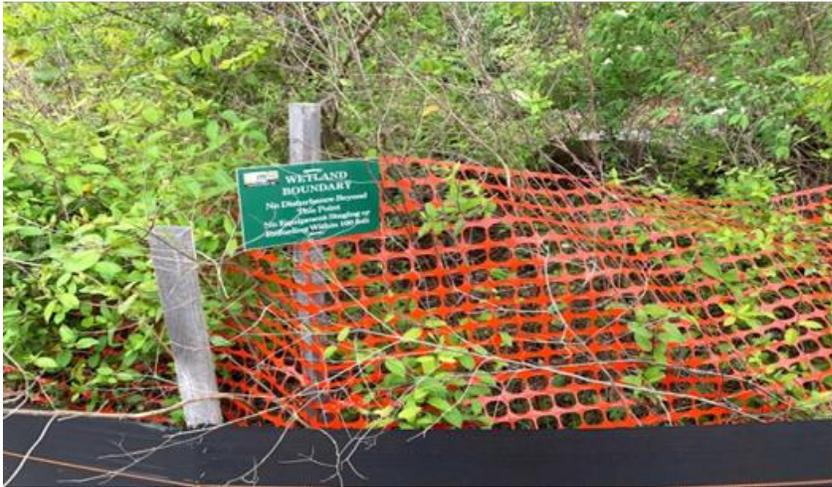
- 1) This protected “Wetland Boundary” sign indicates wetlands have been identified on the site plan and are being protected. There are no wetlands behind this orange protective fencing. There are two storm drain pipes, a partially daylighted stream and some small trees behind this very small area of orange fencing. Were there wetlands on the original site plan required to be protected? If so, they are gone. Why is VDOT claiming this is an area is protected wetlands?

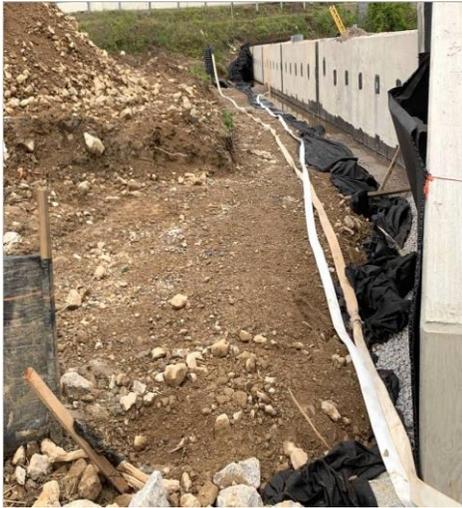
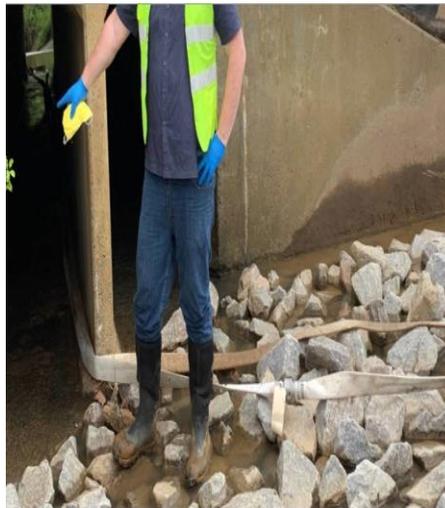
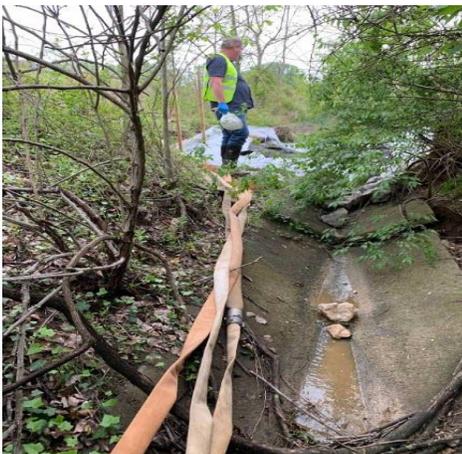
- 2) Additionally, the clover leaf on the east side of the I-66 East bound lane is the lowest part of the entire site (certainly one of them). There is a difficult stream crossing where sediment from the site is bypassing the concrete box culvert and entering a section of daylighted stream. It is evident there have been attempts by VDOT to try and prevent sediment from entering the stream based on this 2) unique pumping mechanism we identified on site. Hoses run the entire length of the culvert box drain (from the I66 westbound lane) which included an electric pump to pump sediment laden water down the stream bed under the I66 east lane. The hoses are laying right in the stream bed then turn 90 degrees and run up a steep slope on the other side of the highway where turbid water is pumped into dirt bags to help filter out the sediments. While we appreciate the extraordinary effort to develop this unique BMP, we have concerns the next big rain even these hoses will be washed down stream, potentially pulling the dirt bags and the sediment in them into the creek.

The electric pump was also disconnected when we were on the scene Friday evening 4/24 which means this, self-designed BMP only works when contractors are on site and when it is actually plugged into a generator. I personally don't feel this is an adequate solution. I find it hard to believe this was a BMP identified on the original site plan and approved by the state?
