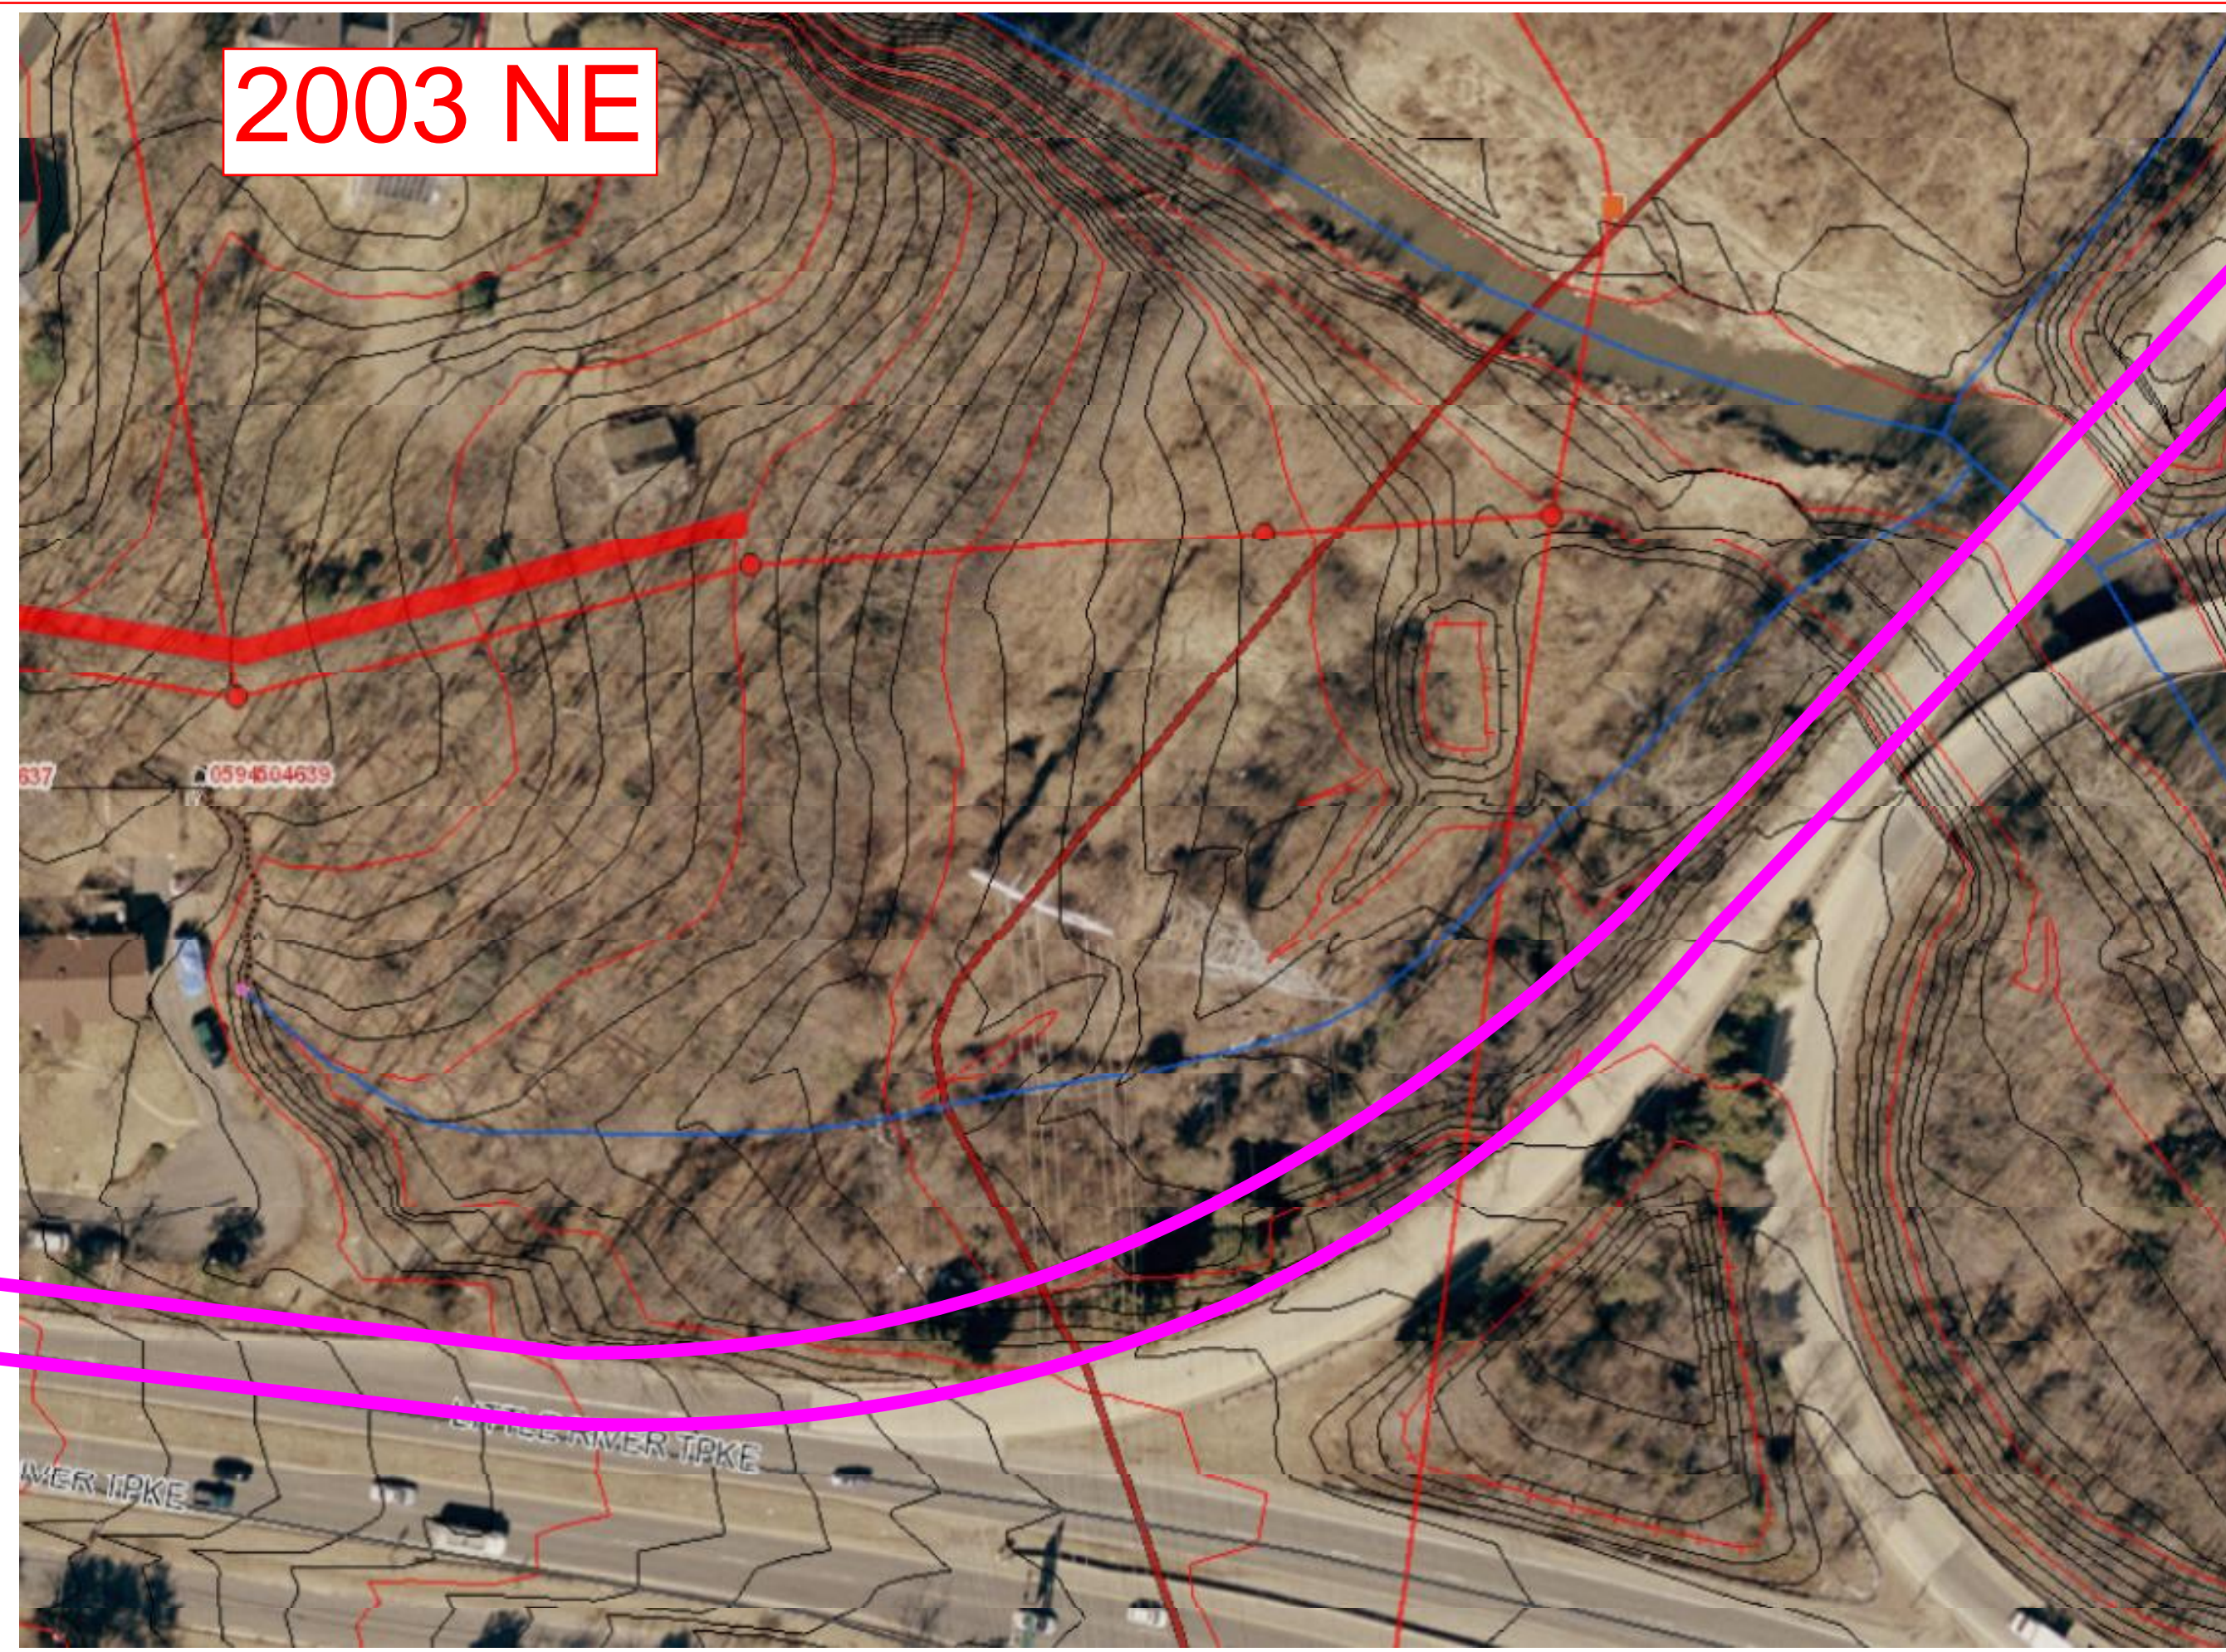
10. 2003 NE - GIS:

Staging area for hotlanes construction prior to I-495 widening and realignment of off ramp. Note approximate new location of off ramp.

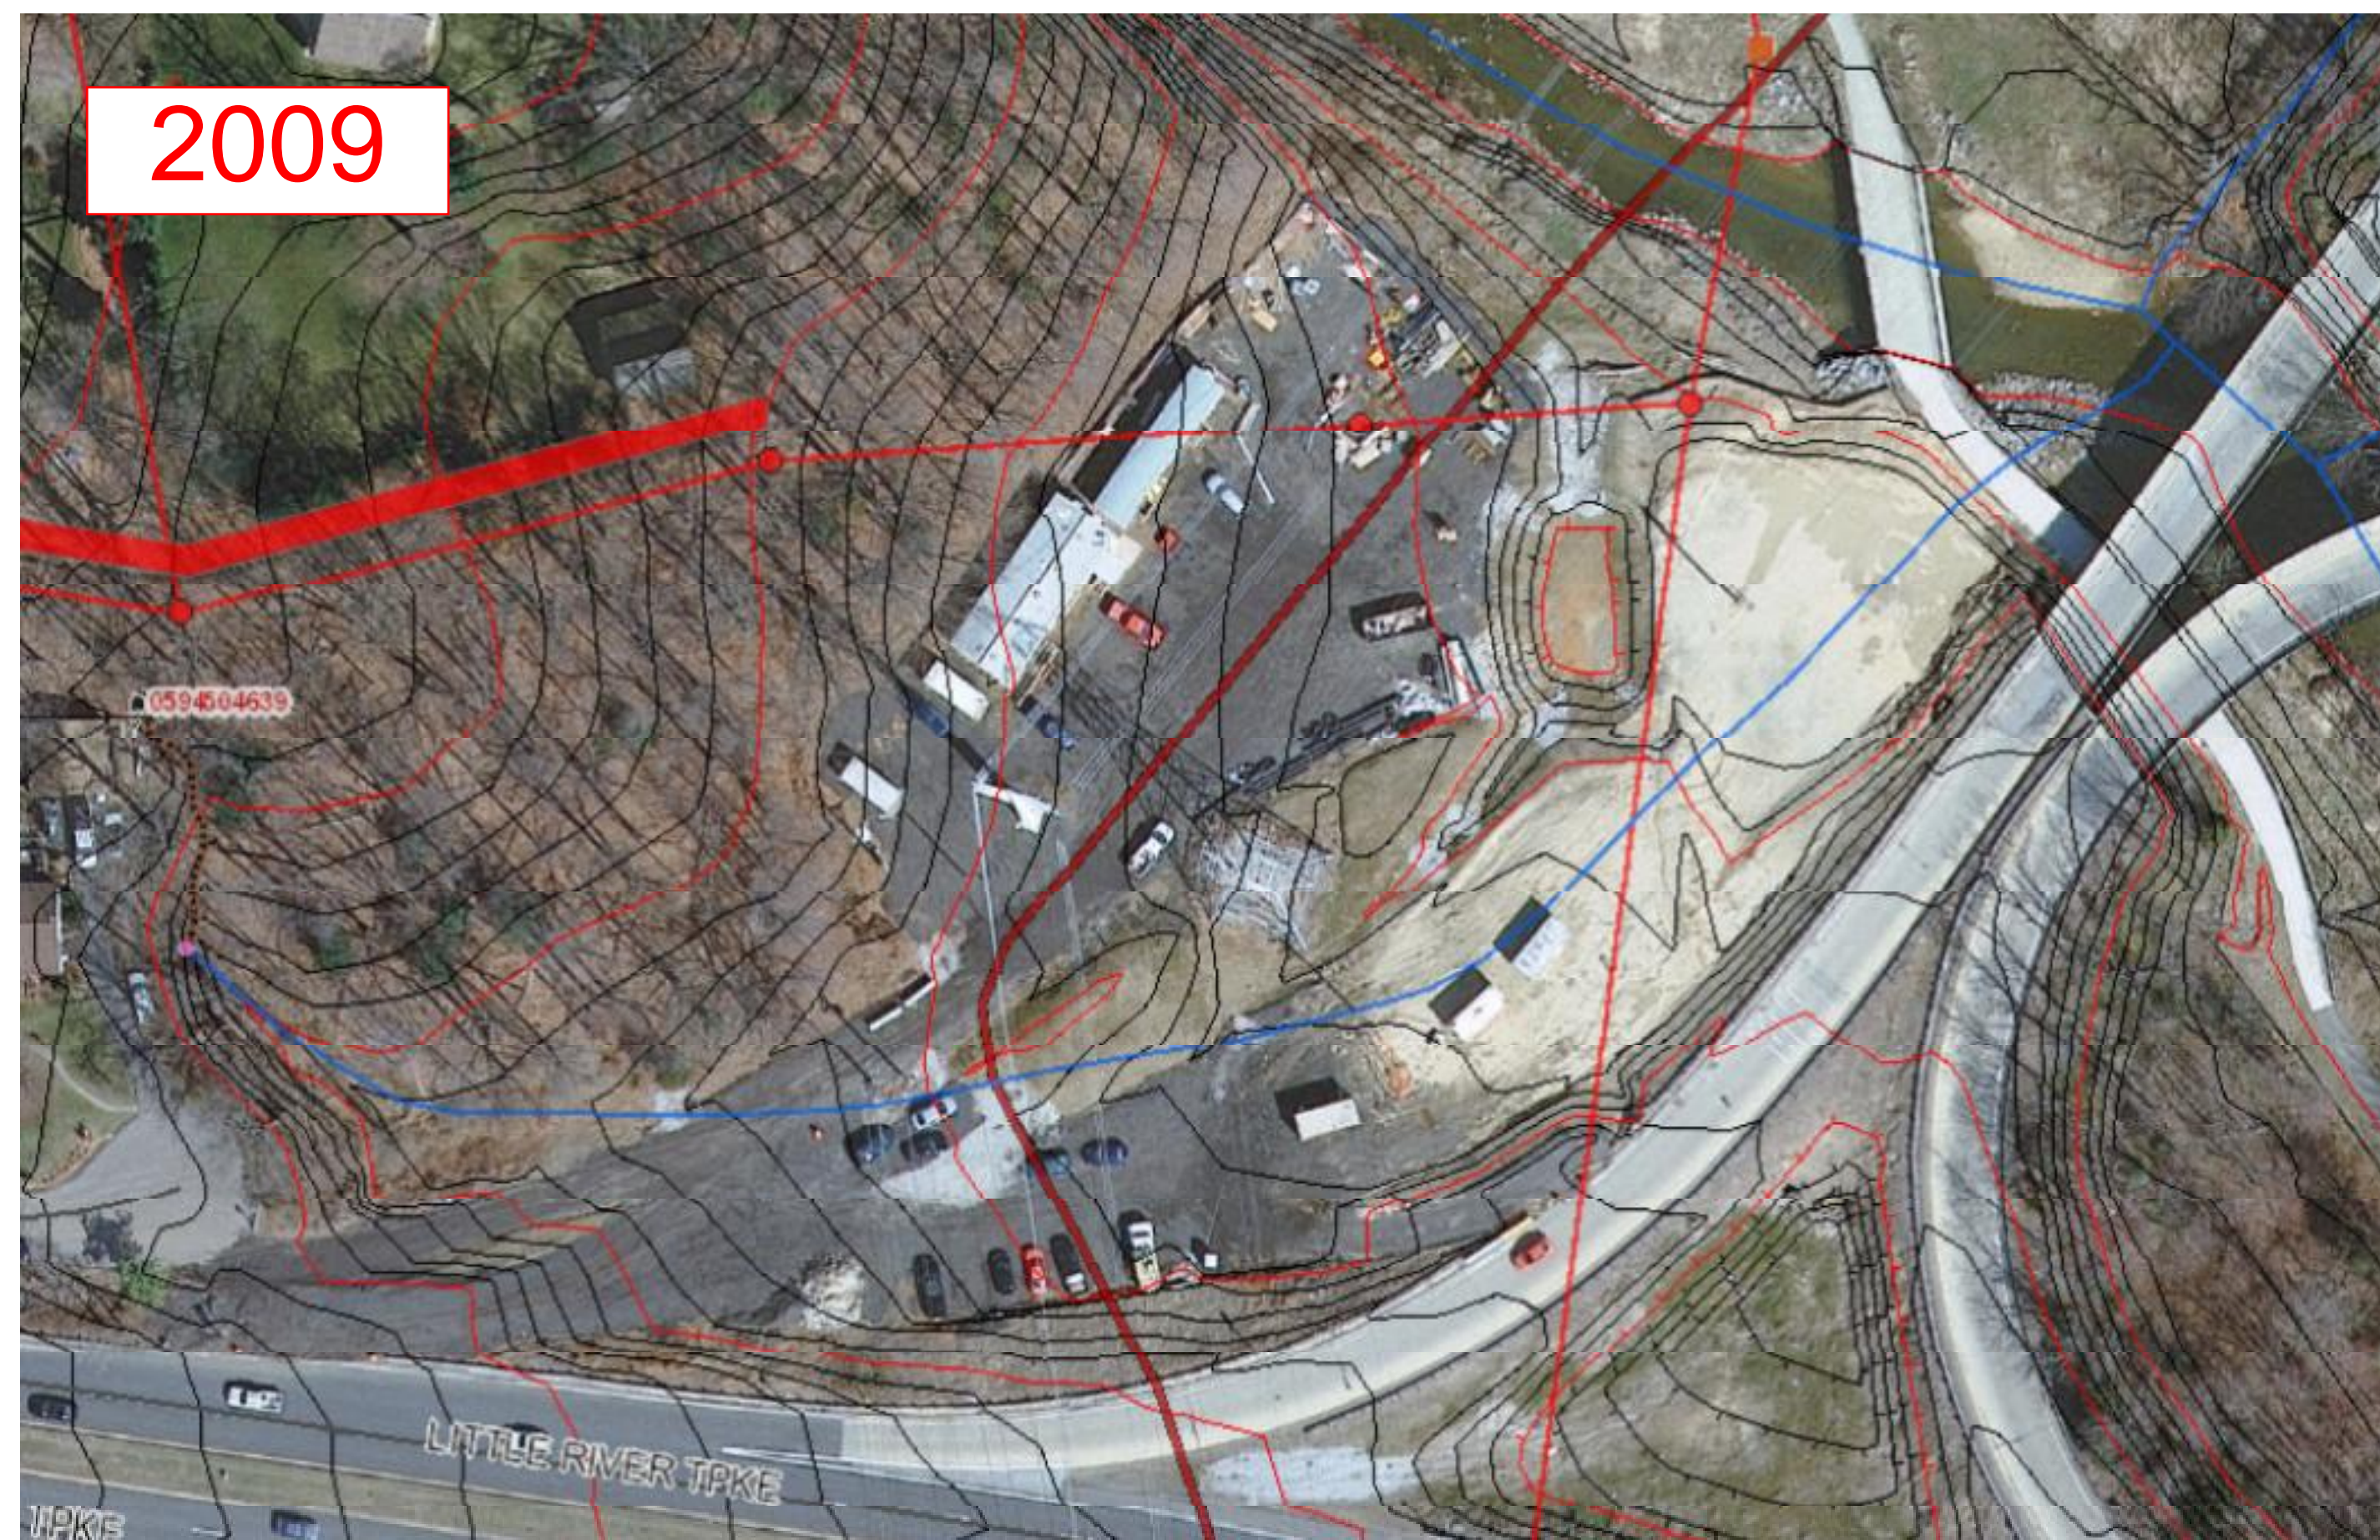
11. 2009 - GIS:

CONCERN:

Note impact of staging area at height of construction.

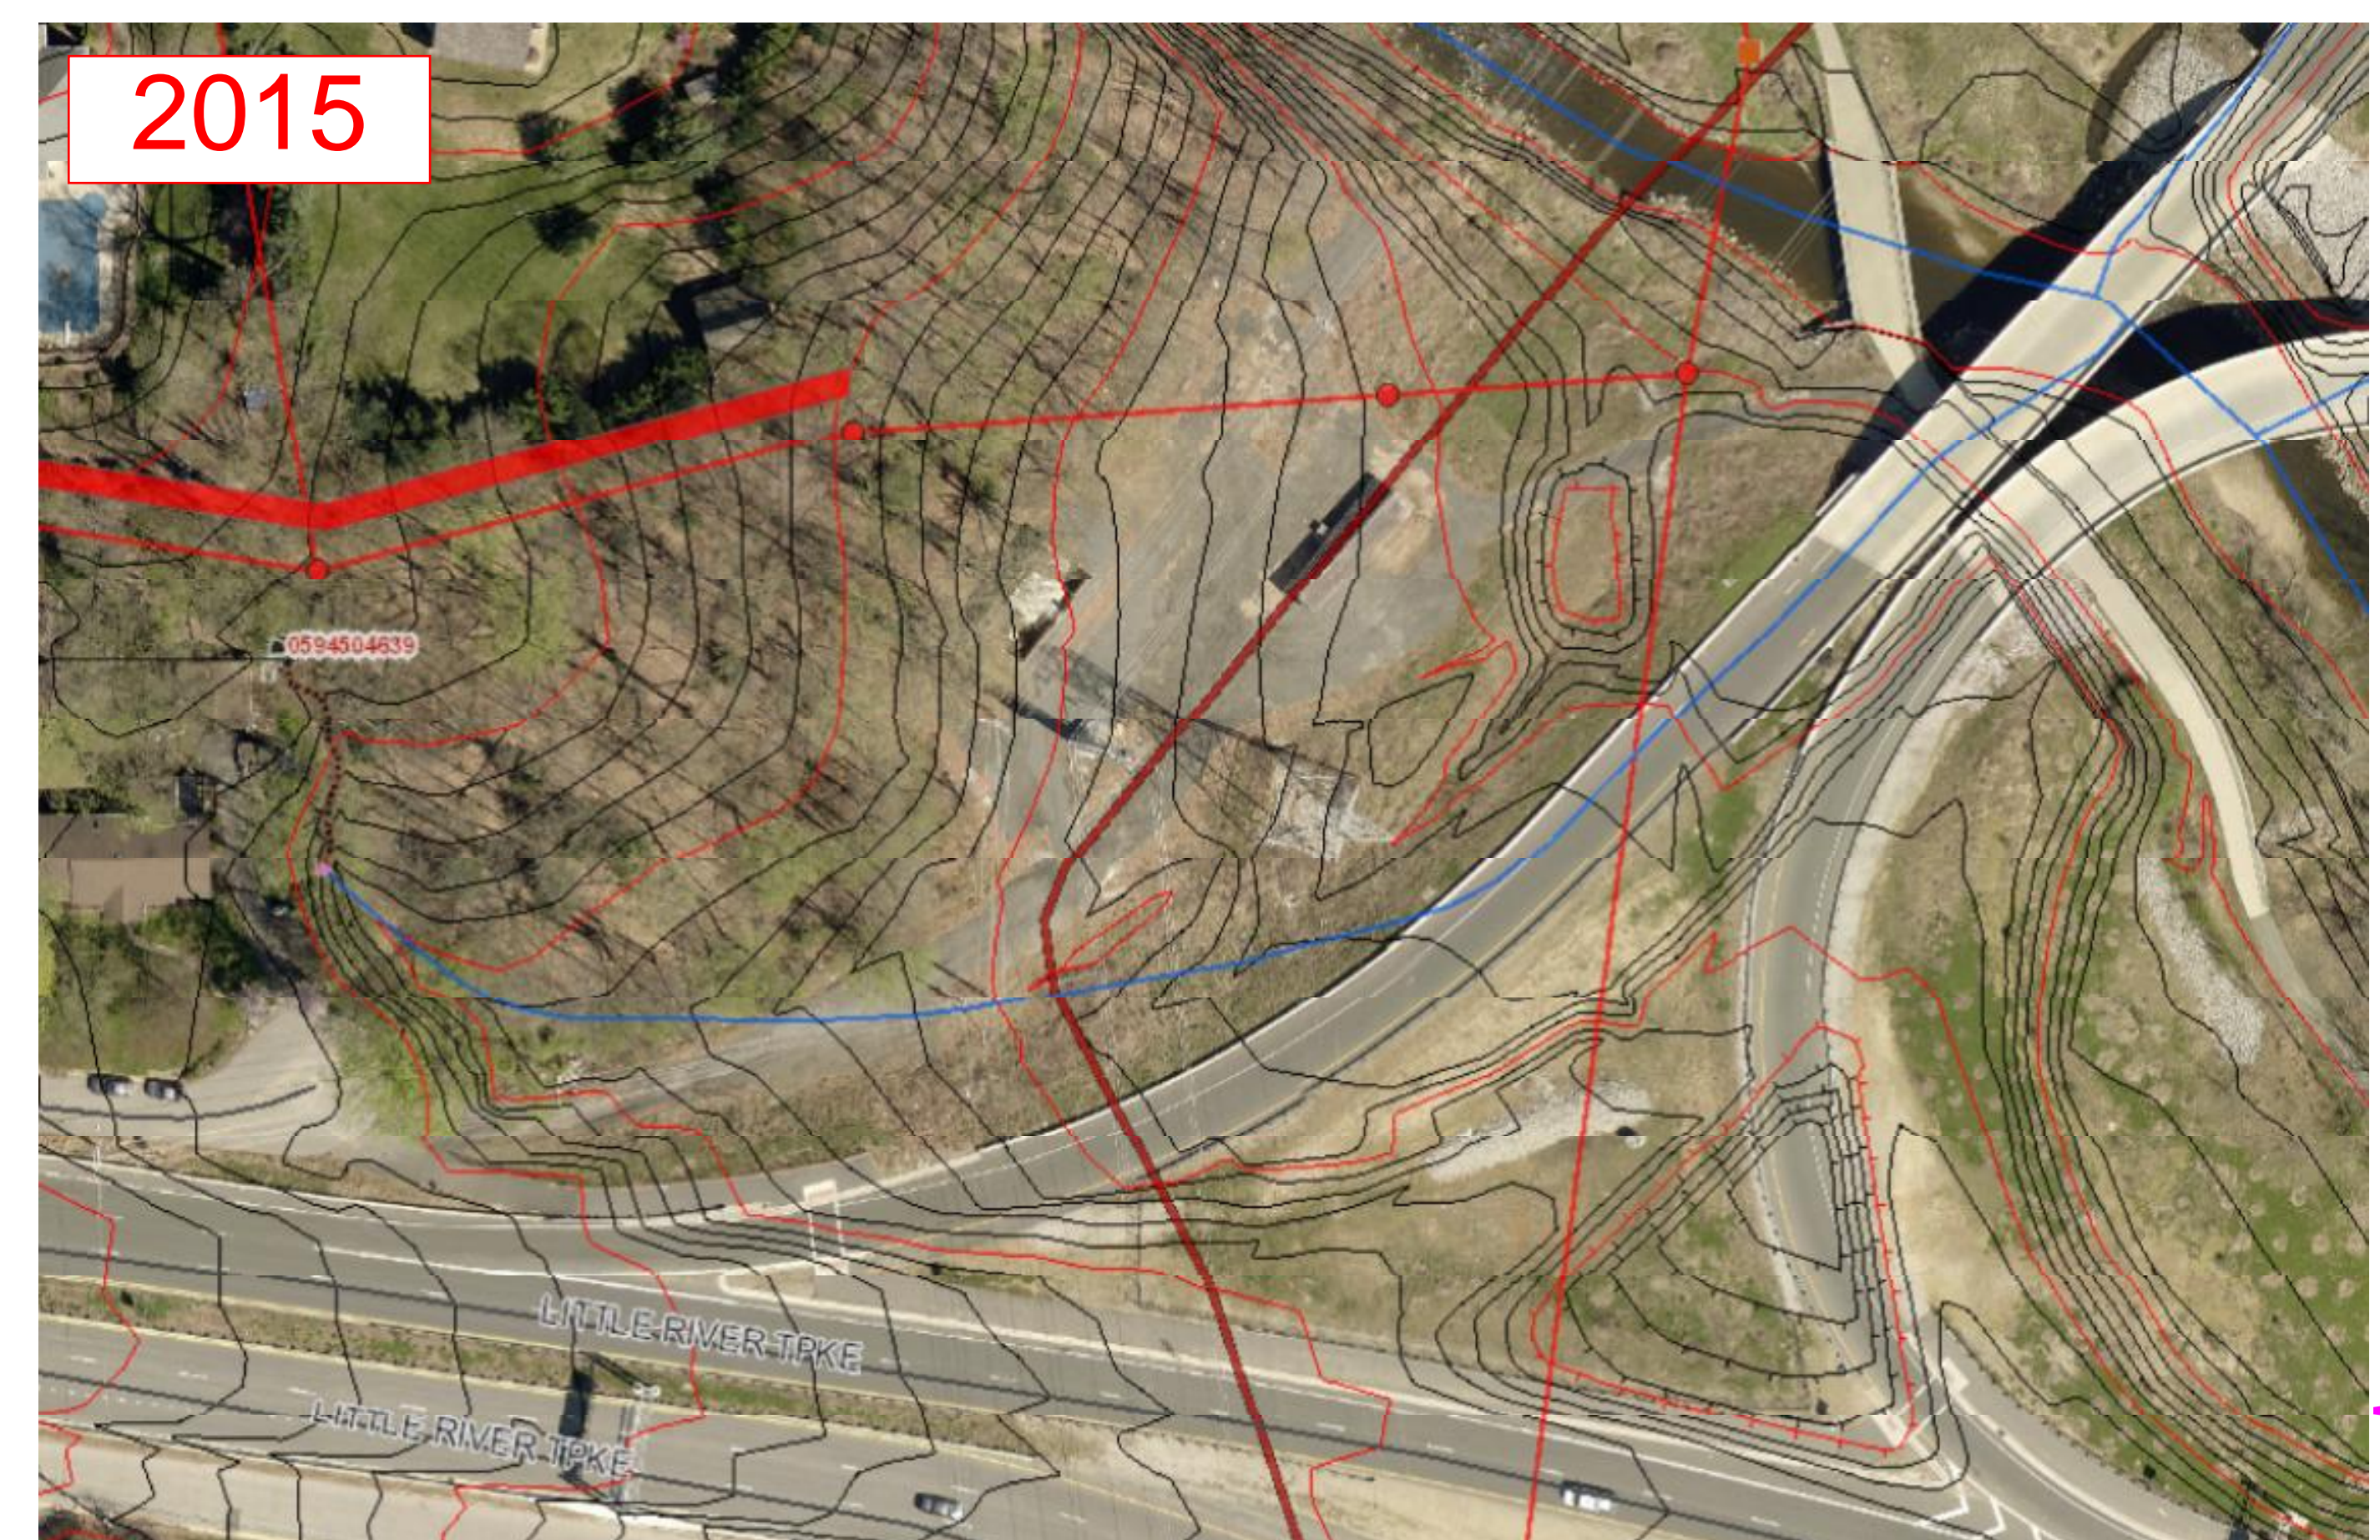
12. 2015 - GIS:

CONCERN:

Note impact of staging area even after equipment has been largely removed.

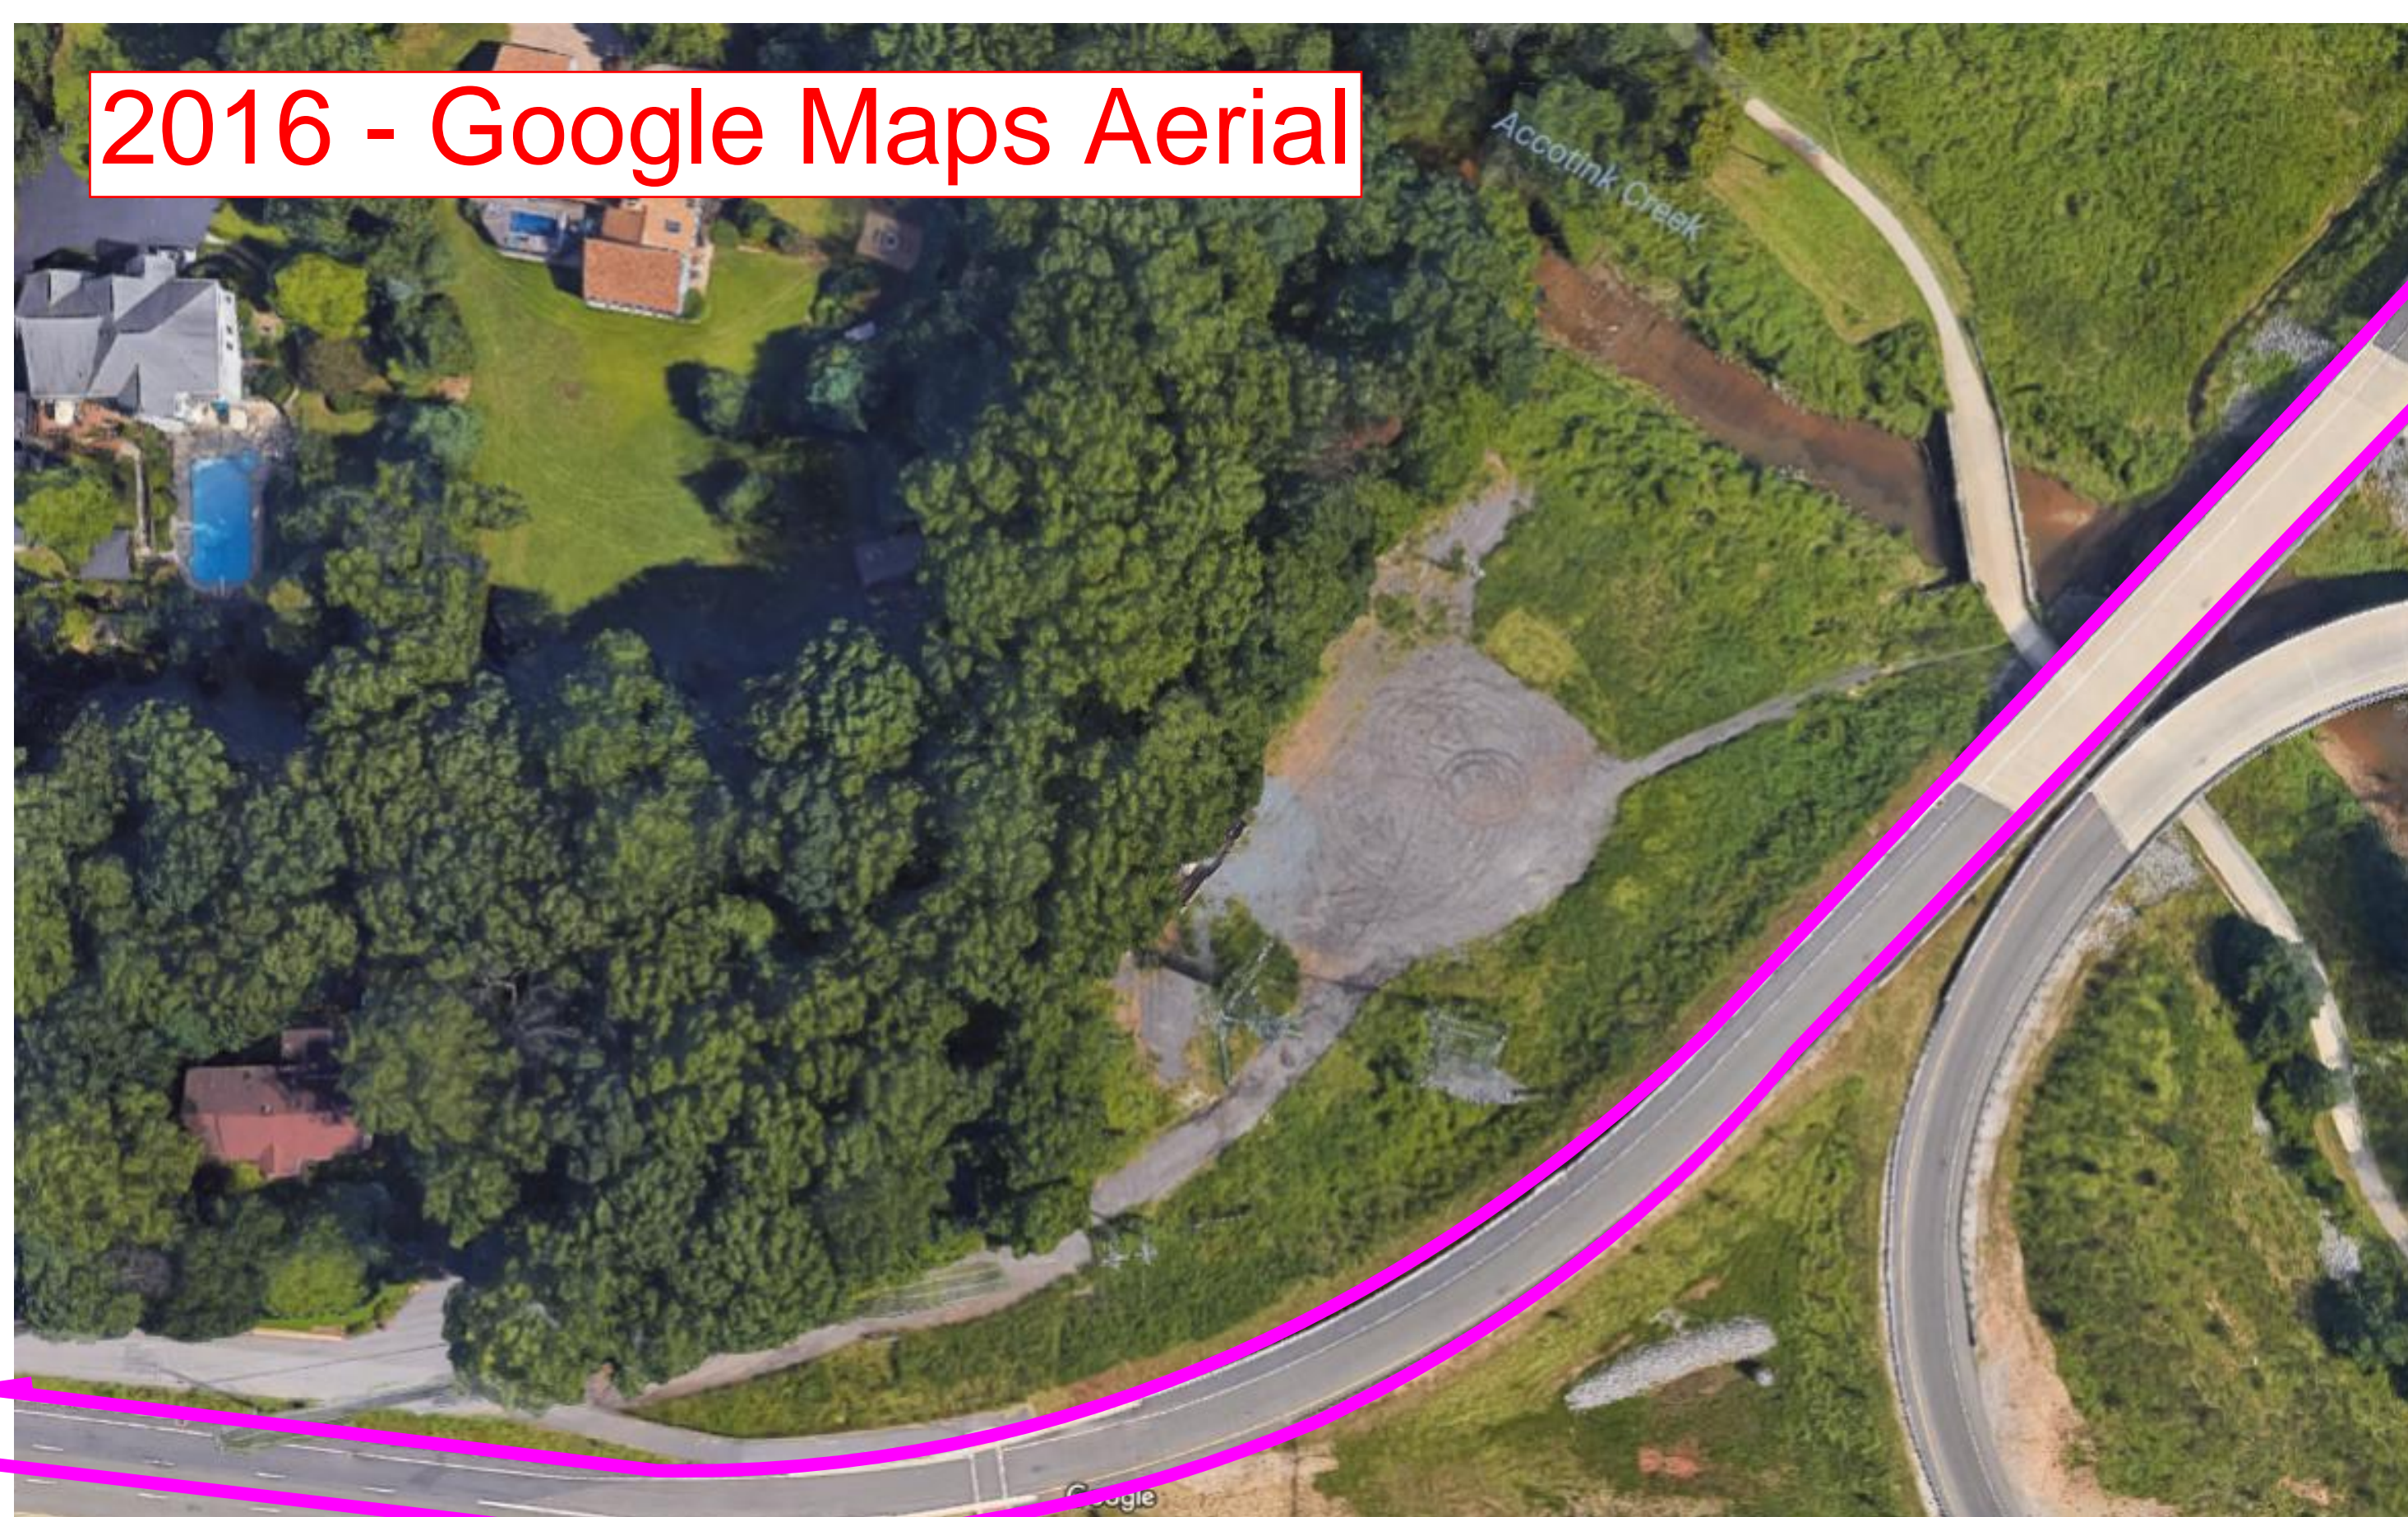
13. 2016 - Google Aerial:

CONCERN:

A. Note area of impervious surface years after staging area is closed.

SUGGESTIONS:

B. Due to the overhead transmission lines this area cannot be reforested however the vegetation should be returned to a high quality meadow for the entire area of impact.

C. This should include deep tilling of soil and planting with an approved native meadow seed mix.

D. Warranty of restoration work should continue until native vegetation is thoroughly established throughout the Limit of Disturbance.
