I-495 Culvert Outfall and Wetland Evaluation - April 2017

I-495 Culvert Outfall and Wetland Evaluation

I-495 Culvert Outfall
Accotank Creek Stream Valley Park

Prepared by the NVSWCD
March 2017

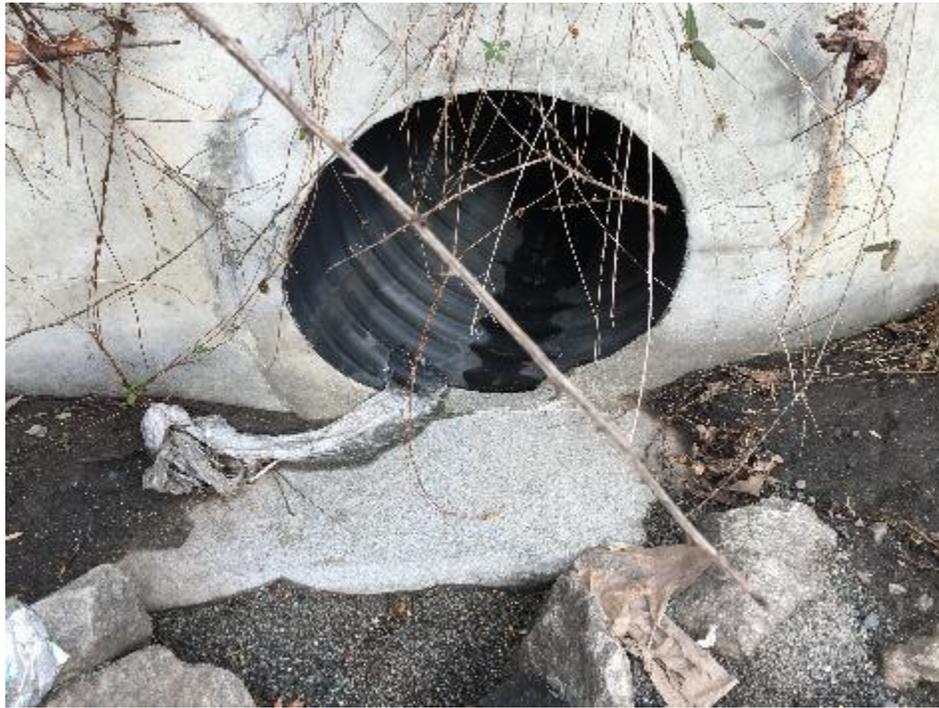
Culvert outfall and the receiving channel: The culvert is a 24.0-inch corrugated plastic pipe. The hydraulic and hydrology data for this specific culvert has not been available. The culvert is not shown on Fairfax County GIS, and no information on its drainage area is available.

However, observations in the field suggest that the culvert drainage area is limited to I-495 impervious surface only and that the original culvert appears to have been extended while the I-495 Express lane was constructed.

The 24.0" culvert

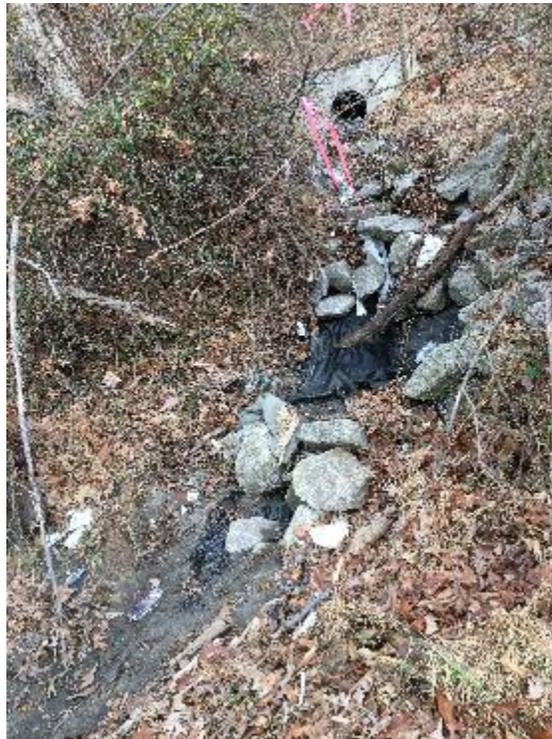
A rock apron consisting of Class I rip rap protects the culvert outlet. The rip rap apron is approximately 12.0 feet wide and 20.0 feet long. The outlet invert drops in elevation at the end of rip rap apron. The drop is also lined with Class I rip rap. The elevation difference between the end of the outlet protection apron and the invert of receiving channel is approximately seven feet.

The outfall protection has been impacted by the discharge from the culvert. Some of the rocks have been moved. Portions of the apron is covered with sediment transported through the culvert. A portion of the existing rip rapped drop has collapsed. The outfall protection seems to be inadequate in protecting the downstream receiving channel.

Culvert outlet protection and drop

- a. Rearrangement of the existing rocks to protect the culvert's immediate outfall. The existing rocks could be rearranged to build a shallow plunge pool at the culvert outfall. Existing rocks can be used to repair the damaged drop and turn the drop into two or three step-pools. All the activities could be performed manually. For step pools additional rocks might be needed.

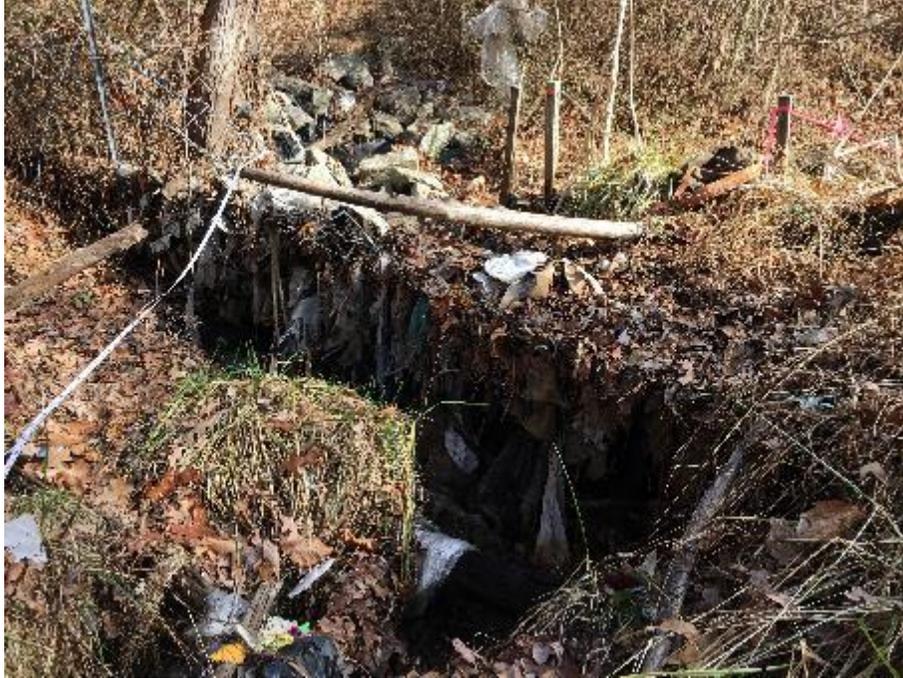
A blockage exists at the beginning of the receiving channel. The blockage has been caused by the existing VDOT right of way (ROW) fence partially blocking the stream. The receiving channel starting at the end of the rip rap apron extends approximately 175 feet before the channel ties into the floodplain and disappears.

Blockage caused by the RW fence

- b. Removal of an existing blockage caused by the existing ROW fence that crosses the stream. This can be done manually. The ROW fence should be reinstalled correctly to prevent future blockage.

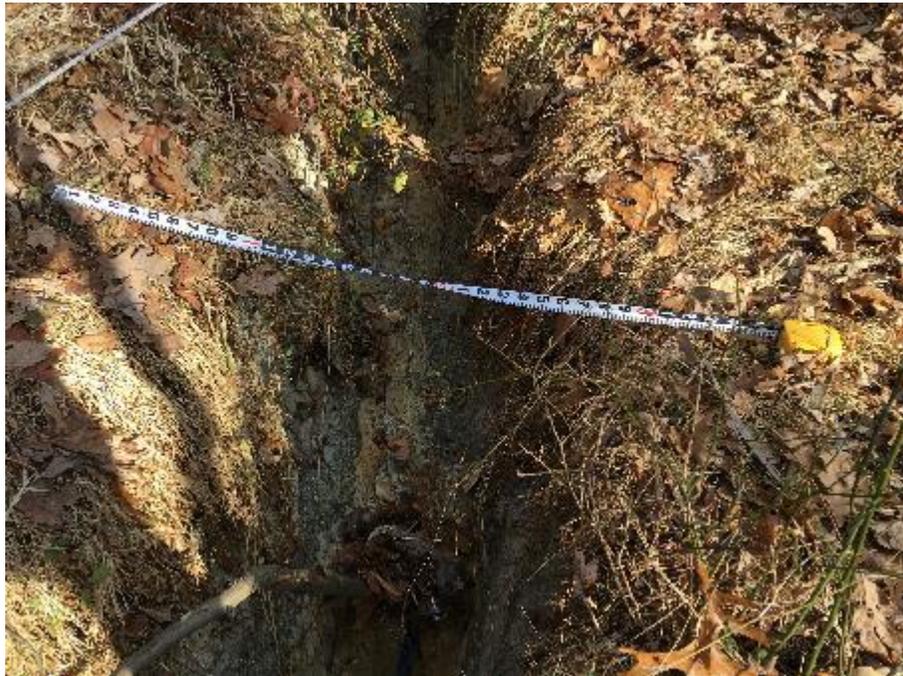
A culvert under the Cross County Trail connects the floodplain with the Accotink Creek. A portion of the receiving channel is located within the Accotink Creek RPA boundary. The first 90.0 feet reach starting at the end of the culvert outlet apron is highly incised. Channel banks are vertical and in some places undercut. The channel width varies between 2.0 and 4.0 feet. The average channel depth is approximately 3.0 to 4.0 feet. This reach is highly impacted by the discharge from the culvert and continues to erode.

The upper incised reach

- c. Spot stabilization of the remaining reach where the channel is incised and active erosion is in progress. This could be done with little need for re-grading the channel banks. The land disturbance activities will be limited. Needed material can be partly harvested from within the surrounding forest. These include logs that can be salvaged from the existing fallen trees. Stabilization could include installing man-made blockages within the channel to slow velocity and allow the rise in stream invert through sediment accumulation behind the blockage. The NVSWCD has built such man-made blockages as part of a demonstration project in Huntley Meadows Park. A variety of techniques can be implemented manually to slow the erosion and reduce erosion-induced sediment transport¹.

- d. Undercut bank areas within the stabilized channel sections would cut off with hand tools to remove cantilevered sediment and establish a stable bank profile. This sediment would be sequestered within the channel upstream of the blockages and stabilized with native plants.

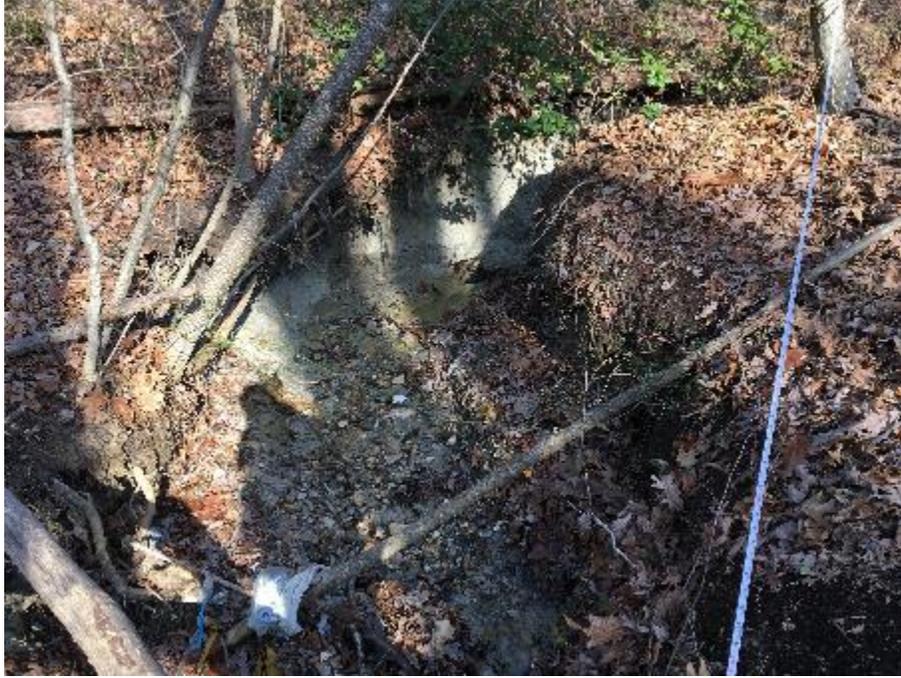
Downstream from this reach the channel becomes wider with an increase in width-to-depth ratio. The channel becomes more stable with gentler slopes compared with the upstream reach. This section contains two major natural blockages, which have resulted in a significant rise in stream invert immediately upstream from the blockage. At the end of this section the stream gradually ties into the floodplain where no defined bed and bank is present.

The end of upper incised reach

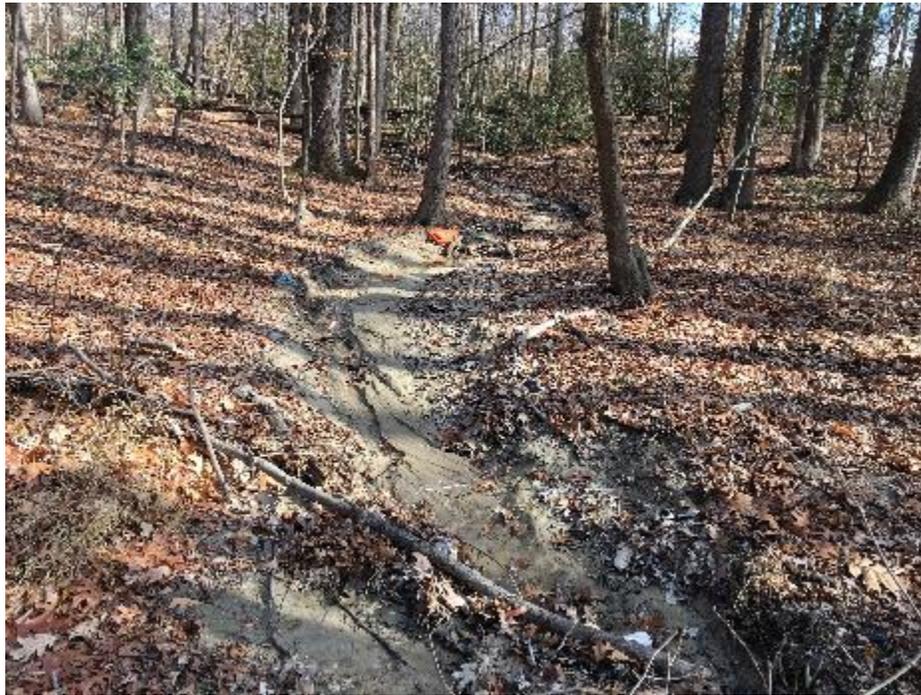
Channel ties into the floodplain (looking upstream)

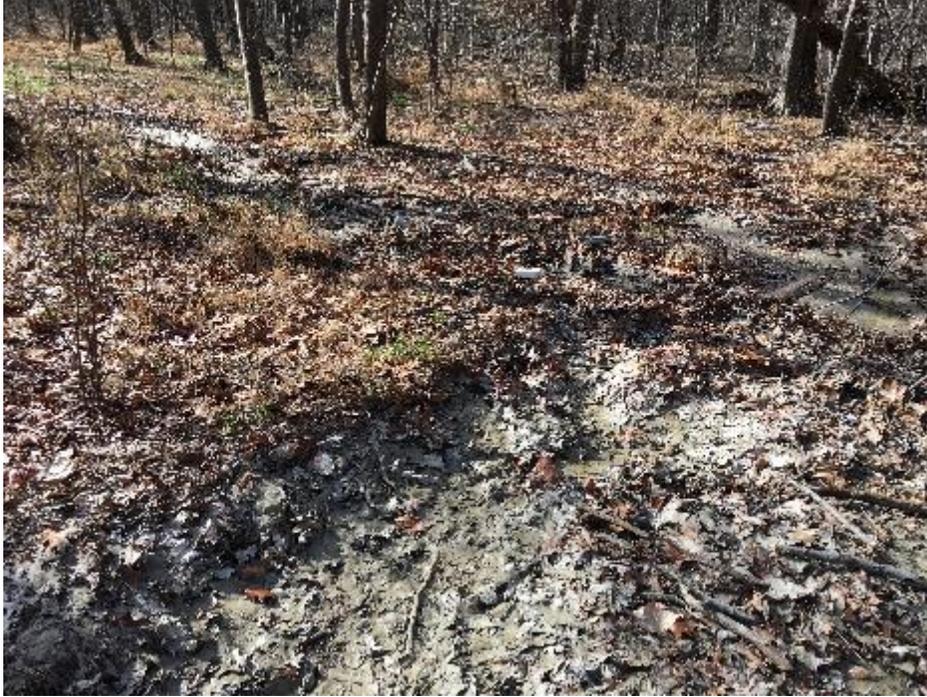
Channel ties into the floodplain (looking downstream)

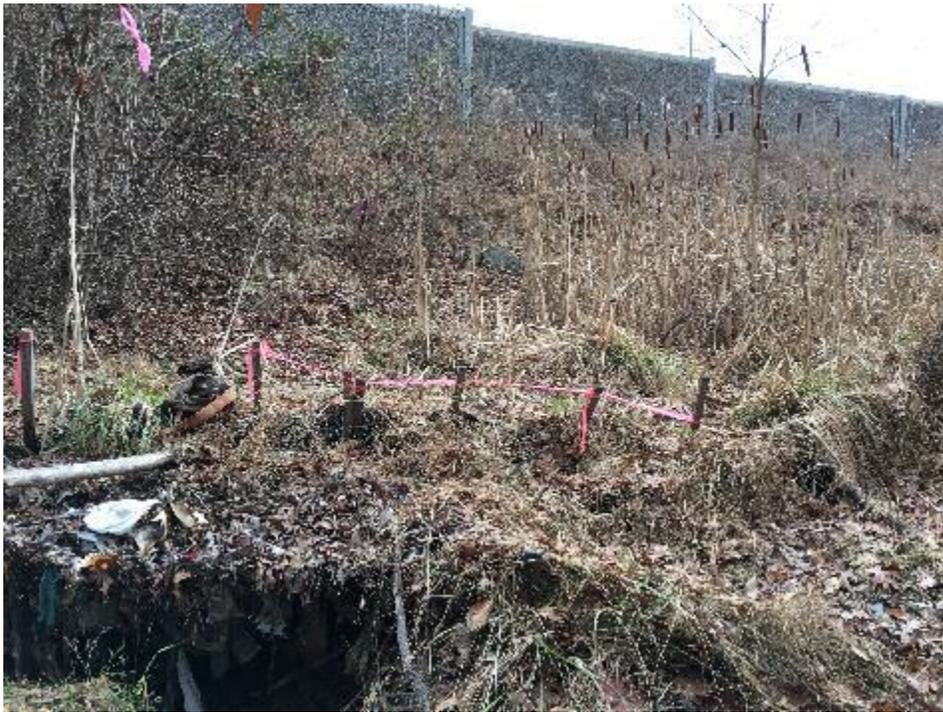
1. Emergent Wetland: Approximately 800 square feet (20' x 40'). It is dominated by cattails (*Typha* sp.) and sedges (*Carex* spp.). It is located between the existing ROW fence and the I-495 embankment. The wetland is within the VDOT right of way. An existing silt fence, presumably installed during I-495 Express Lane construction, acts as a berm and helps to retain the wetland on the lower side. Field indicators including the obvious recent earth disturbance at the toe of the road fill slope, sedimentation and age and type of vegetation as well as later review of Fairfax County aerial imagery confirm that the current emergent wetland was created as a result of the I-495 Express Lane construction. It is unknown whether a previous forested wetland existed at this location. The remaining silt fence has helped the creation of the wetland.

3. During several site visits, the NVSWCD has been able to verify that an area approximately 20x40 exists as wetland. Soil cores taken during a site visit verified the presence of hydric soil. Vegetation mostly consists of wetland plants, primarily cattail. During the November 2016 and January-February 2017 visits, NVSWCD observed clear signs of groundwater seepage into the area designated as the wetland.

The emergent wetland. Stakes hold the silt fence

1. Removing the existing silt fence at the lower side of the wetland. The silt fence presently acts as a berm. Its removal will require an alternative structure to act as the berm. The least intrusive alternative would be large-diameter biologs. It might be possible to expand the wetland footprint by relocating the berm. Doing this will require further study by a wetland specialist. Removing the silt fence and installing a new berm can be done manually.
2. Removing and reinstalling the existing ROW fence. This can be done manually.
3. Introducing new and/or additional wetland plants to enhance biodiversity inside the wetland. All can be done manually.

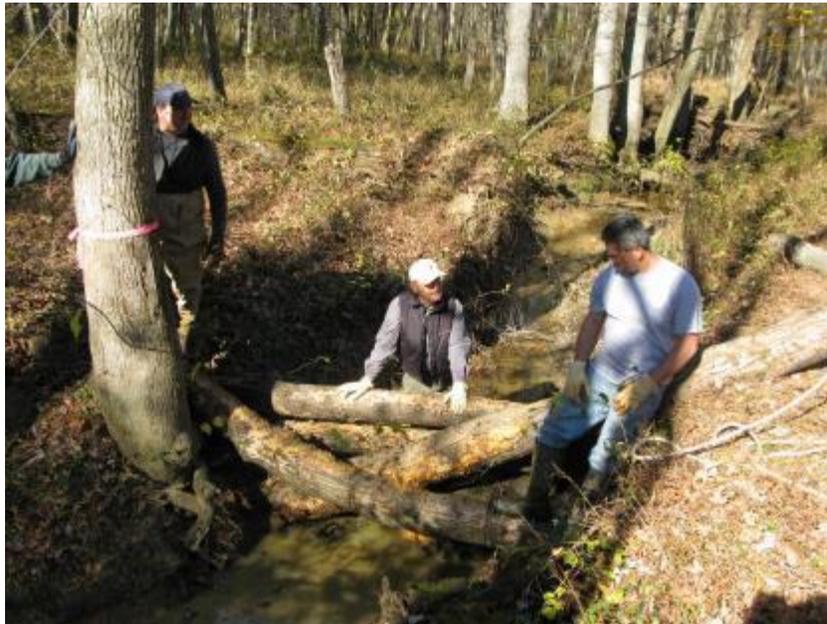
Manmade blockage during construction
Designed and built by the NVSWCD, Huntley Meadows Park

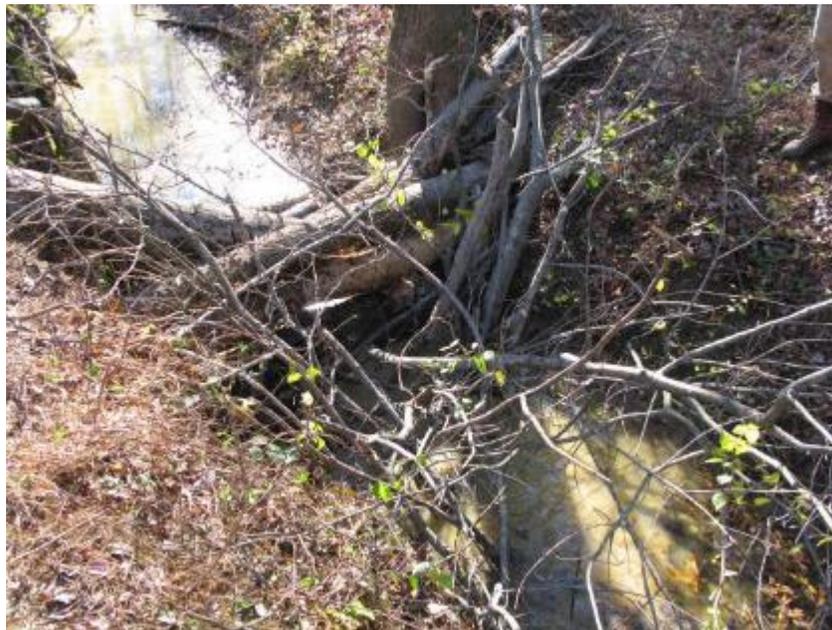
Manmade blockage following construction
Designed and built by the NVSWCD, Huntley Meadows Park

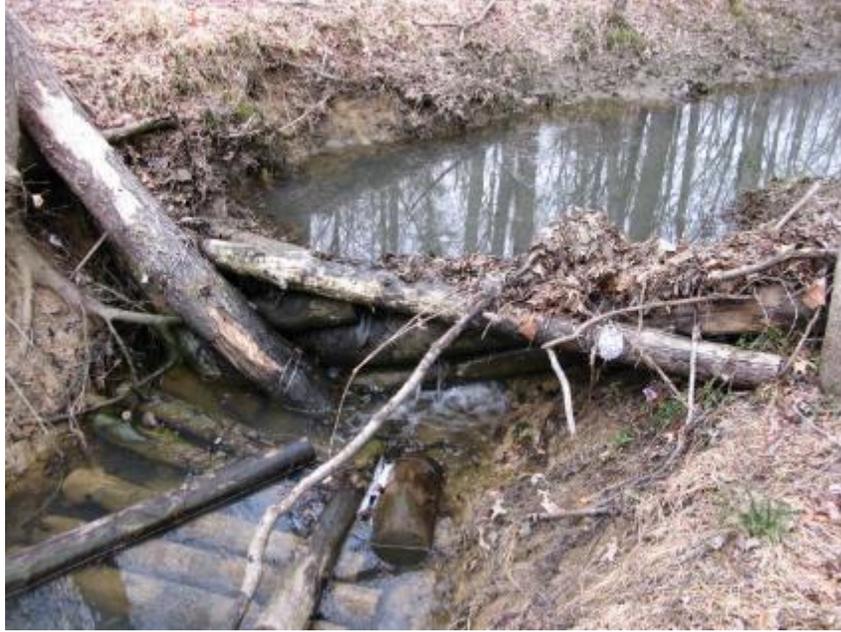
Manmade blockage one year later construction
Designed and built by the NVSWCD, Huntley Meadows Park
