CHAPTER 3

WATERSHED SUMMARIES

The 30 watersheds in the County have been subdivided into 14 groups for reporting purposes. This was done based on characteristics of area, geography and, in most cases, physiographic province and proximity of watersheds to each other.

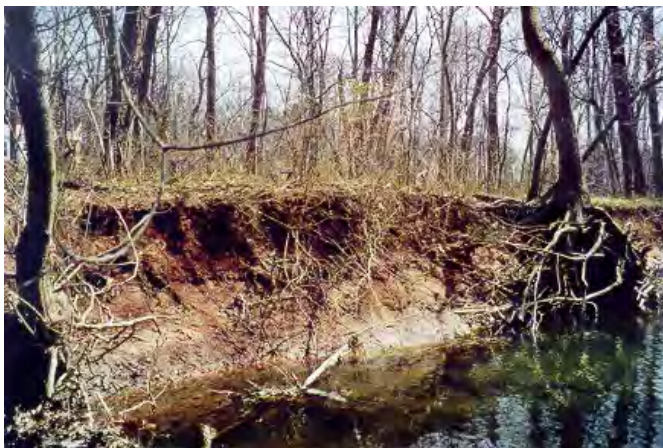
Eroded stream bank and undercut tree root systems are common along the Sugarland Run mainstem.

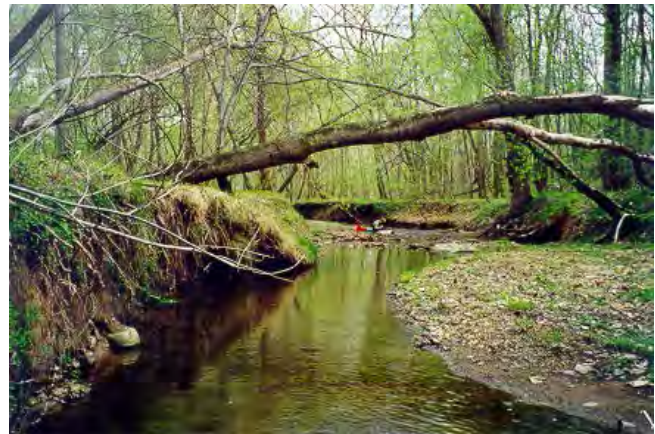
A section of Clarks Branch in the Pond Branch watershed showing signs of stream bank undercutting.

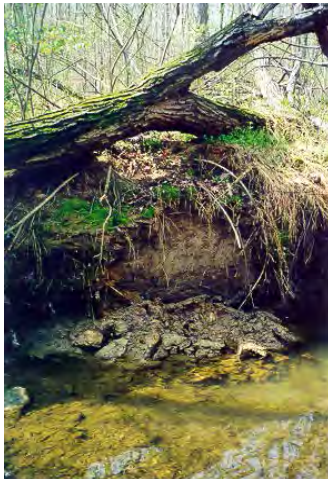
Streambank erosion was common at many locations in the Difficult Run watershed.

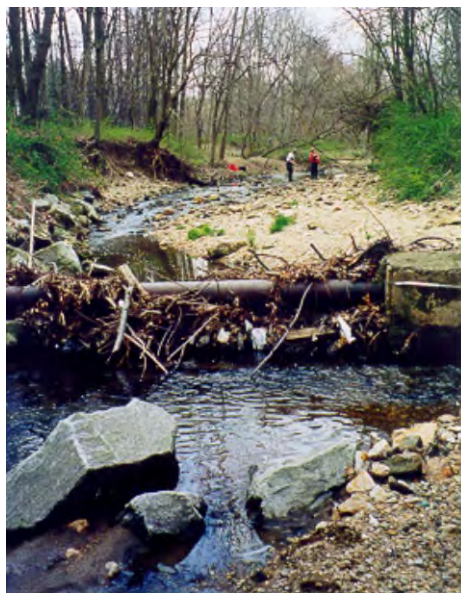
Exposed sanitary pipe running across Little Pimmit Run indicates considerable erosion by the stream.

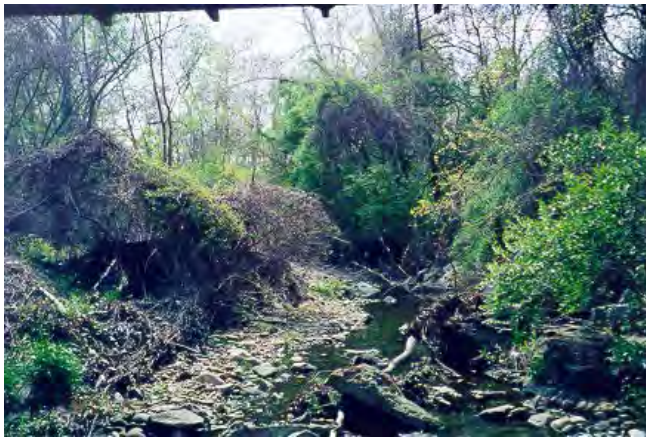
Poor habitat quality characterizes much of Four Mile Run.

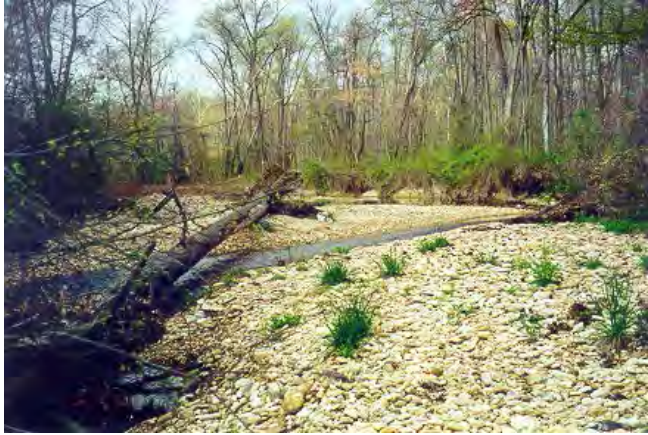
Backlick Run in the Cameron Run watershed suffers from extreme levels of deposition.

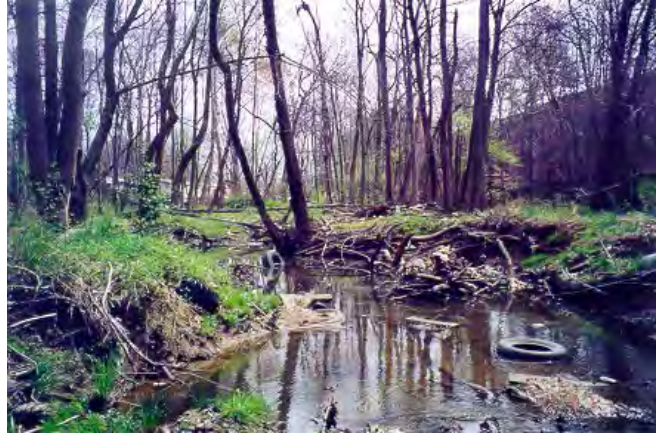
Instream and riparian zone litter was common throughout many portions of Little Hunting Creek.

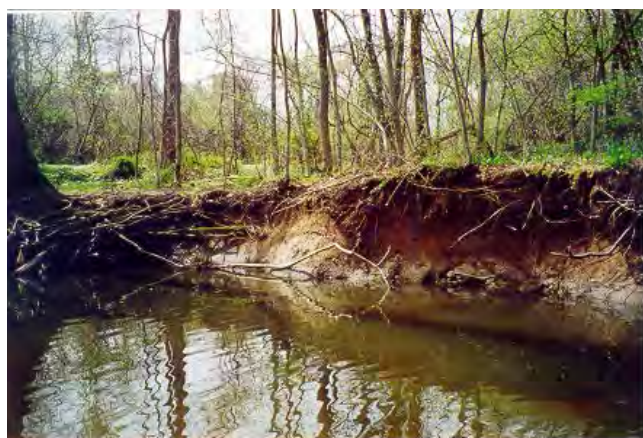
Highly eroded stream banks are common throughout the Accotink watershed.
