## Open House - Lake Accotink Smaller Lake Feasibility Study 20260606

Photo documentation of display graphics

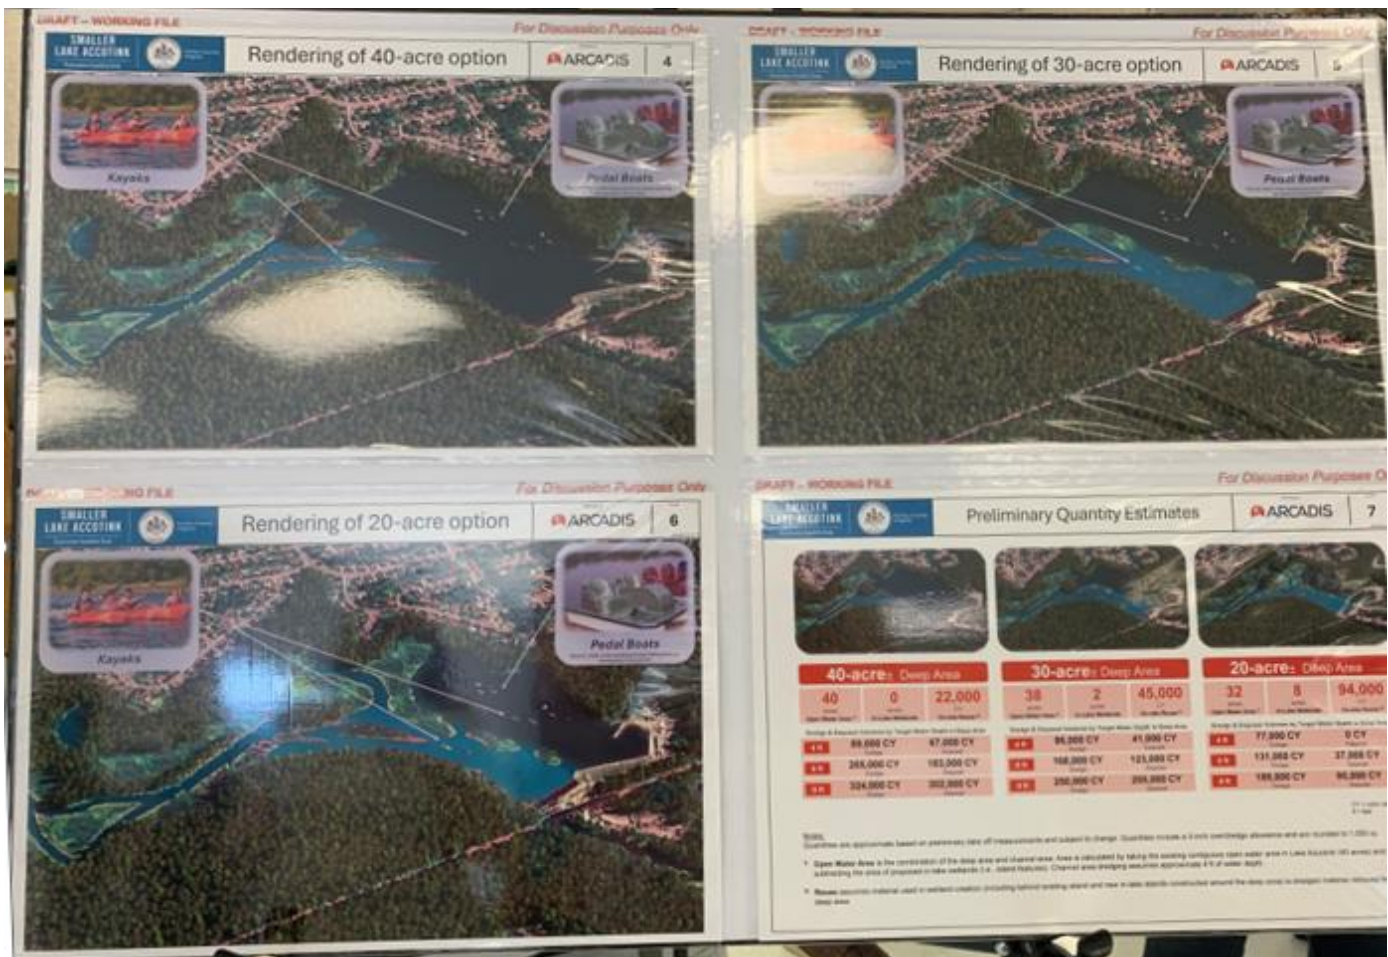
Three lake configuration options – 40 acres, 30 acres, 20 acres

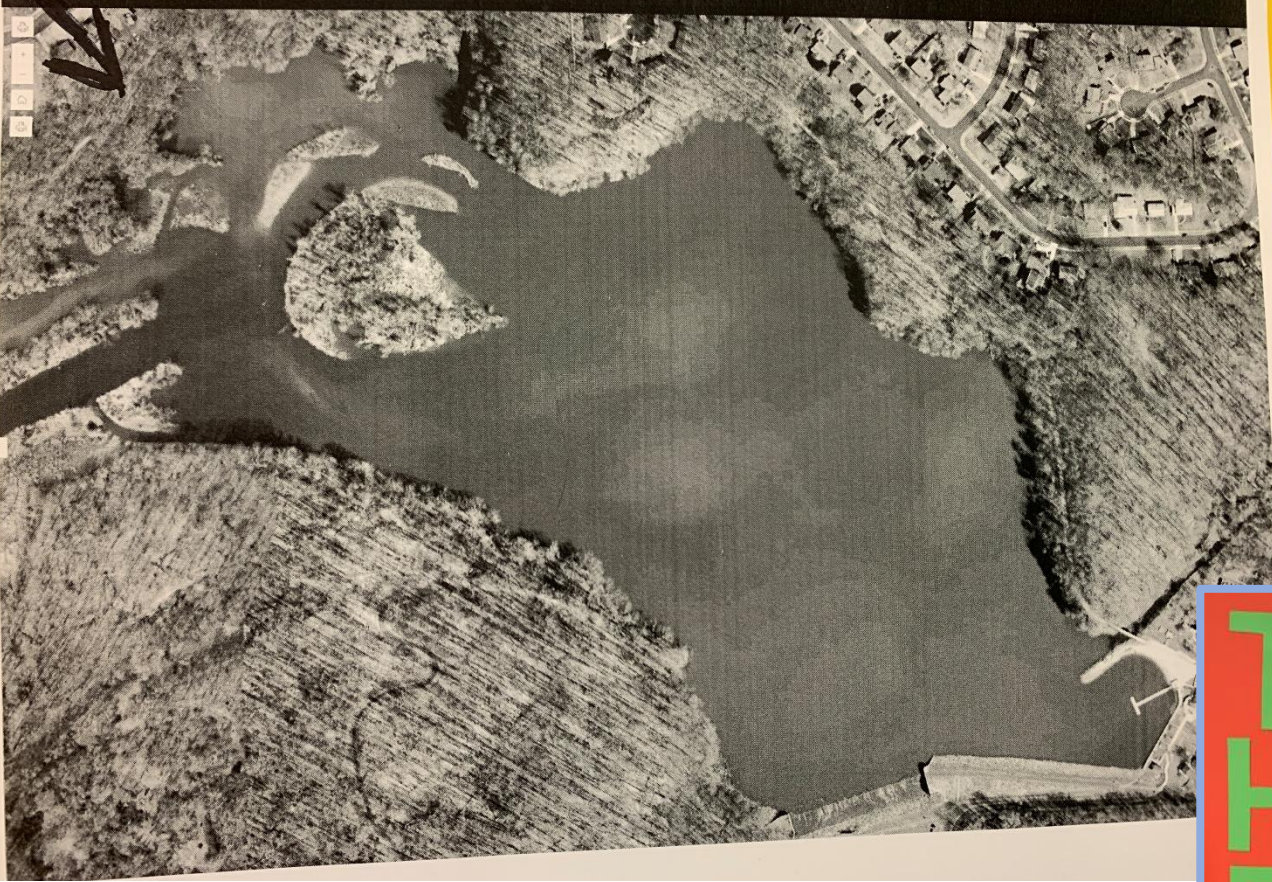
2017

[Save Lake Accotink](#) aerals  
of open water loss

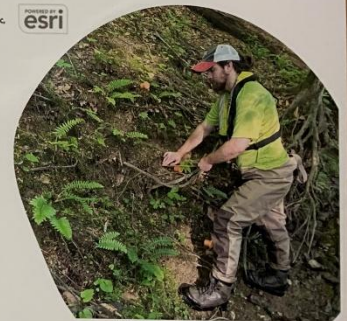
## Ongoing Annual Cross-Section Surveys

USGS measures stream channel erosion

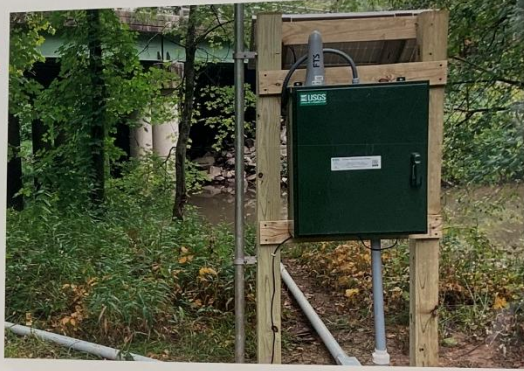
**Accotink Creek at Old Keene Mill Rd  
USGS Station ID – 01654670 (installed Aug 2024)**

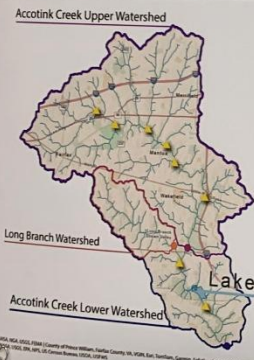
## Explanation

- Accotink Creek at Keene Mill - Station ID 01654670
- Accotink Creek Near Annandale - Station ID 01654000
- Long Branch Near Annandale - Station ID 01654500
- ▲ Accotink Creek Transects

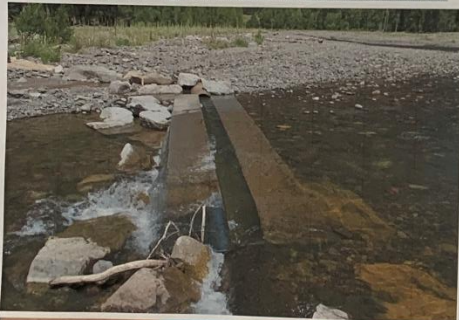
### EXAMPLE OF BEDLOAD SEDIMENT REDUCTION THROUGH A "SEDIMENT VORTEX TUBE"

Example of a sediment vortex tub in the Blanco River, CO. Bedload sediment, which is heavy, falls into the slotted vortex tub and is carried into a cleanout bay where it is deposited. Image courtesy of Wildland Hydrology. <https://wildlandhydrology.com/restoration/Blanco%20River/93/>

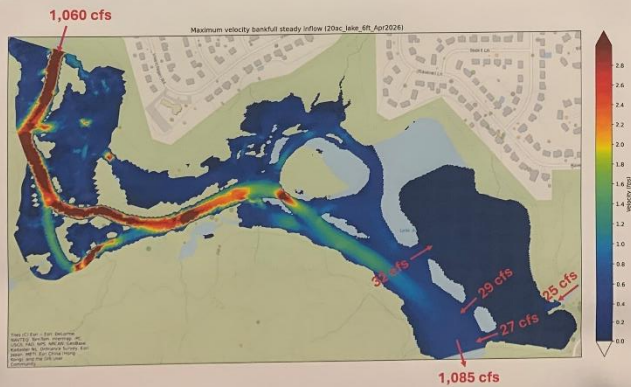
ESTIMATED ANNUAL FLOW AND SEDIMENT DISTRIBUTION FOR A 20-ACRE LAKE ALTERNATIVE (YEAR = 2020)

20-acre configuration – how sediment moves into and through the lake

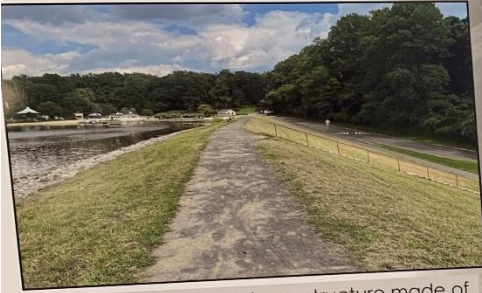
An embankment is a large structure made of compacted earth designed to hold back water by using the mass of material to resist water pressure.

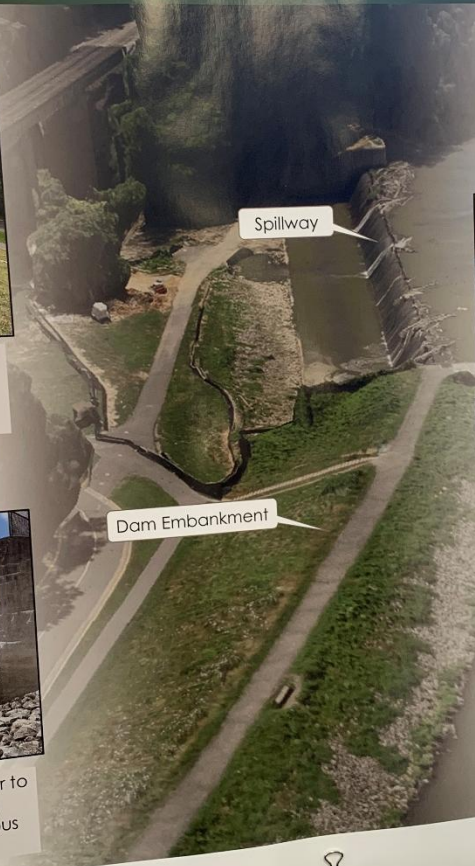
The current condition of the dam is rated as "poor," and engineers determined the spillway is too small for the types of storms that are expected in this area. Research on how to increase spillway capacity is ongoing.

Core samples taken from the spillway are used to test its strength and condition.

The concrete is showing its age with several areas of cracking and spalling.

Monitoring tools called piezometers were installed to track the condition of the embankment.
